**CALSPAN ON-SITE AIR BAG DEPLOYMENT INVESTIGATION**

**CALSPAN CASE NO. 93-9**

**VEHICLE #1 - 1990 FORD TAURUS GL (AIR BAG-EQUIPPED)**

**VEHICLE #2 - 1974 CADILLAC COUPE DEVILLE**

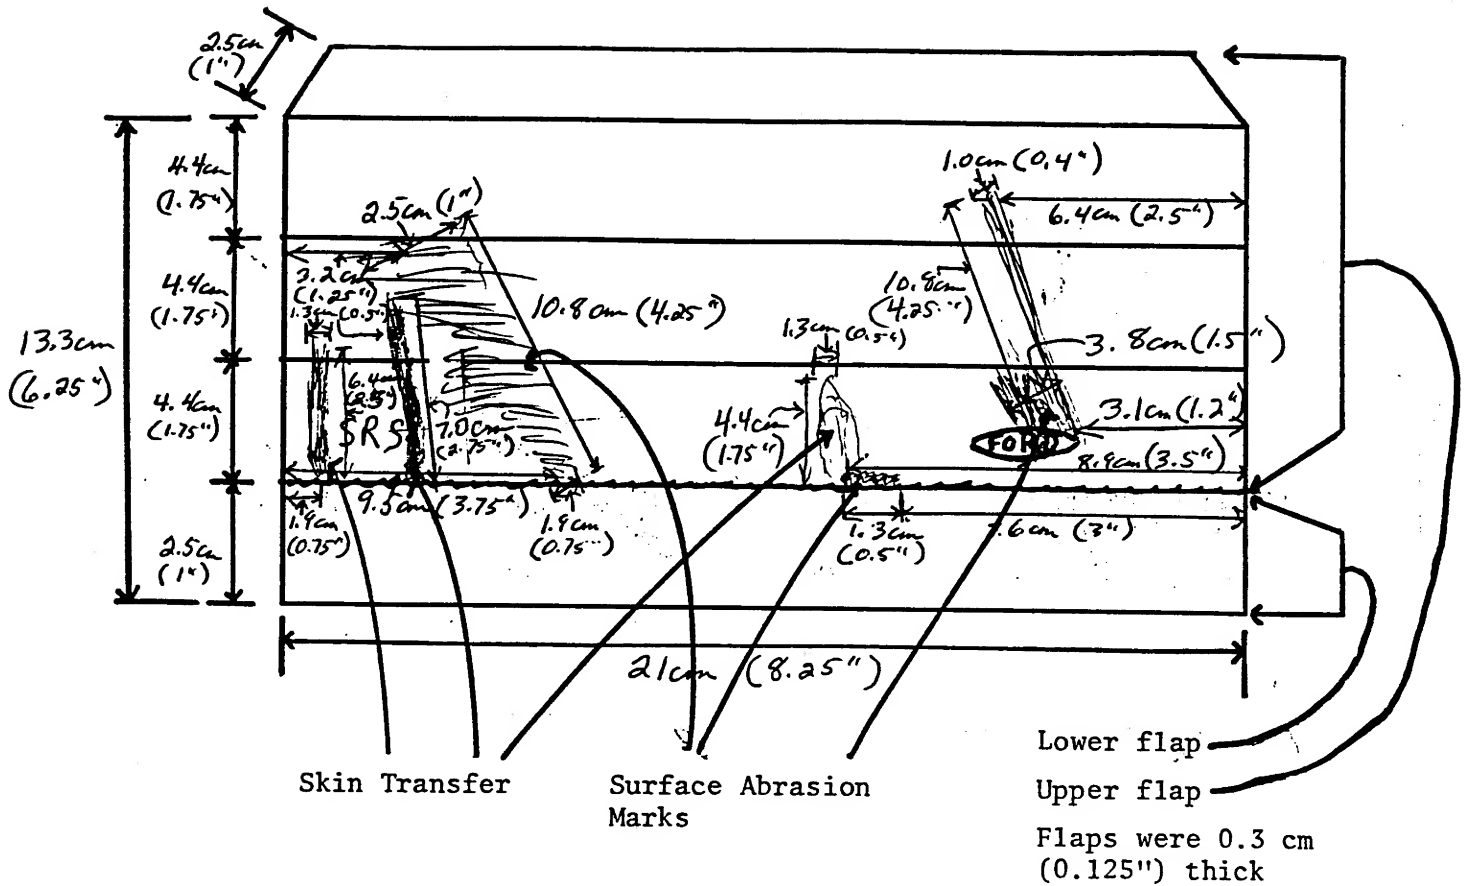
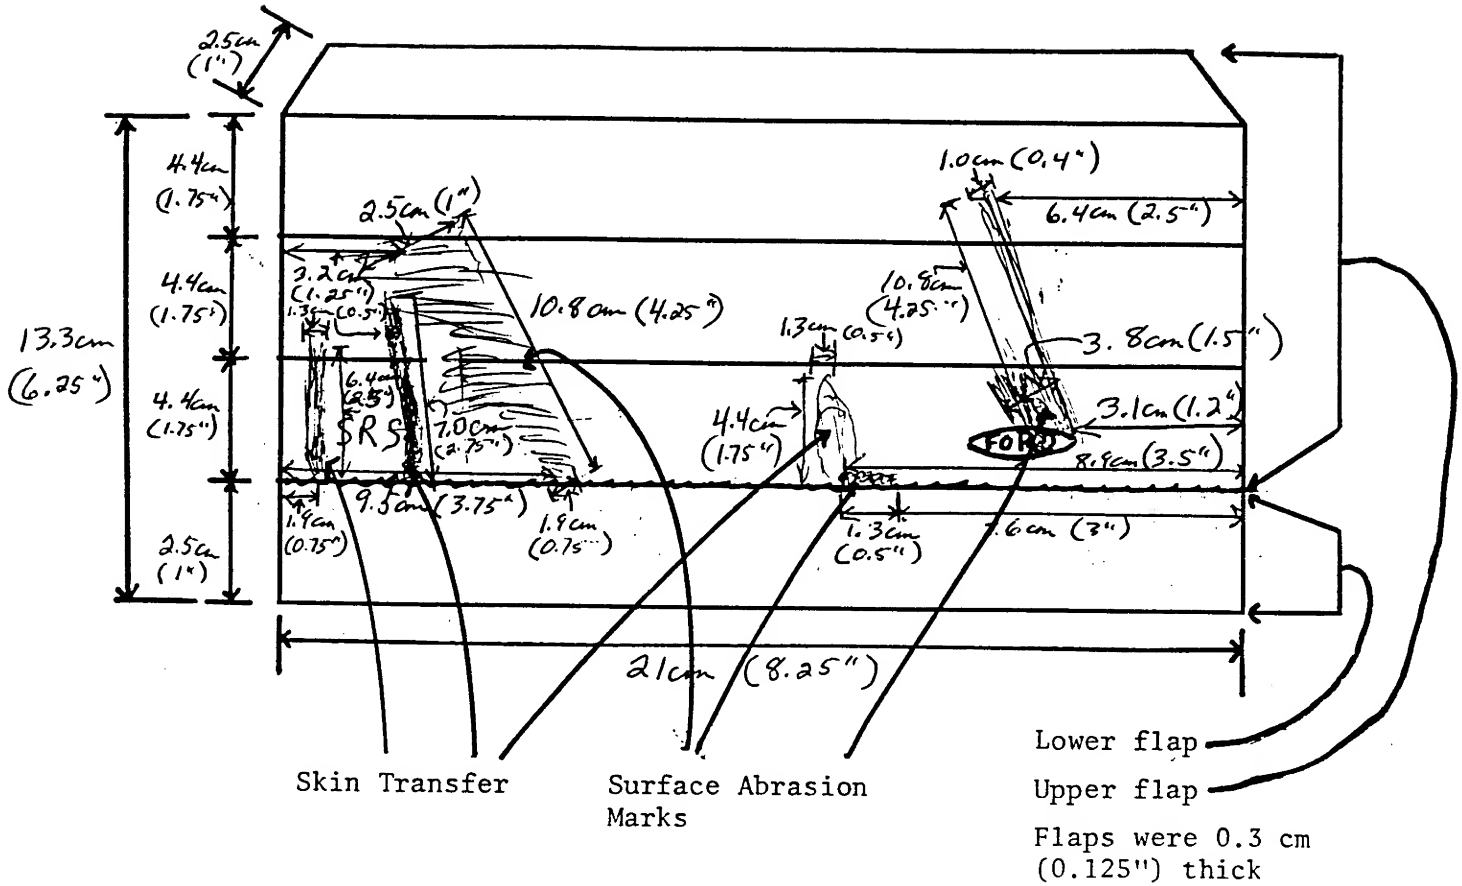
Vehicle #1 - Air Bag Module Cover

The upper flap of the air bag module cover exhibited abraded surface damage which was attributed to the interaction with the driver's necklace during the air bag deployment sequence. For documentation purposes, the abraded surface damage was divided into three areas. The largest and most visible area began along the bottom edge of the upper flap at 9.5 cm (3.75") right of the left corner and extended 10.8 cm (4.25") diagonally upward to the left, ending 3.2 cm (1.25") from the left side edge of the flap.

There were three skin transfer marks noted on the upper air bag module flap which were attributed to contact with the driver's neck during the air bag deployment sequence. The first was 1.3 cm (0.5") wide and began 1.9 cm (0.75") right of the left flap corner along the horizontal seam edge. This transfer extended vertically 6.4 cm (2.5"). The second transfer was also 1.3 cm (0.5") wide and began 4.8 cm (1.9") right of the left flap corner along the horizontal seam edge. This transfer extended vertically 7.0 cm (2.75"). The third transfer began 8.9 cm (3.5") left of the right corner along the bottom edge of the flap and ended 4.4 cm (1.75") above the seam line. This transfer was 1.3 cm (0.5") wide and less visible than the other skin transfer marks.

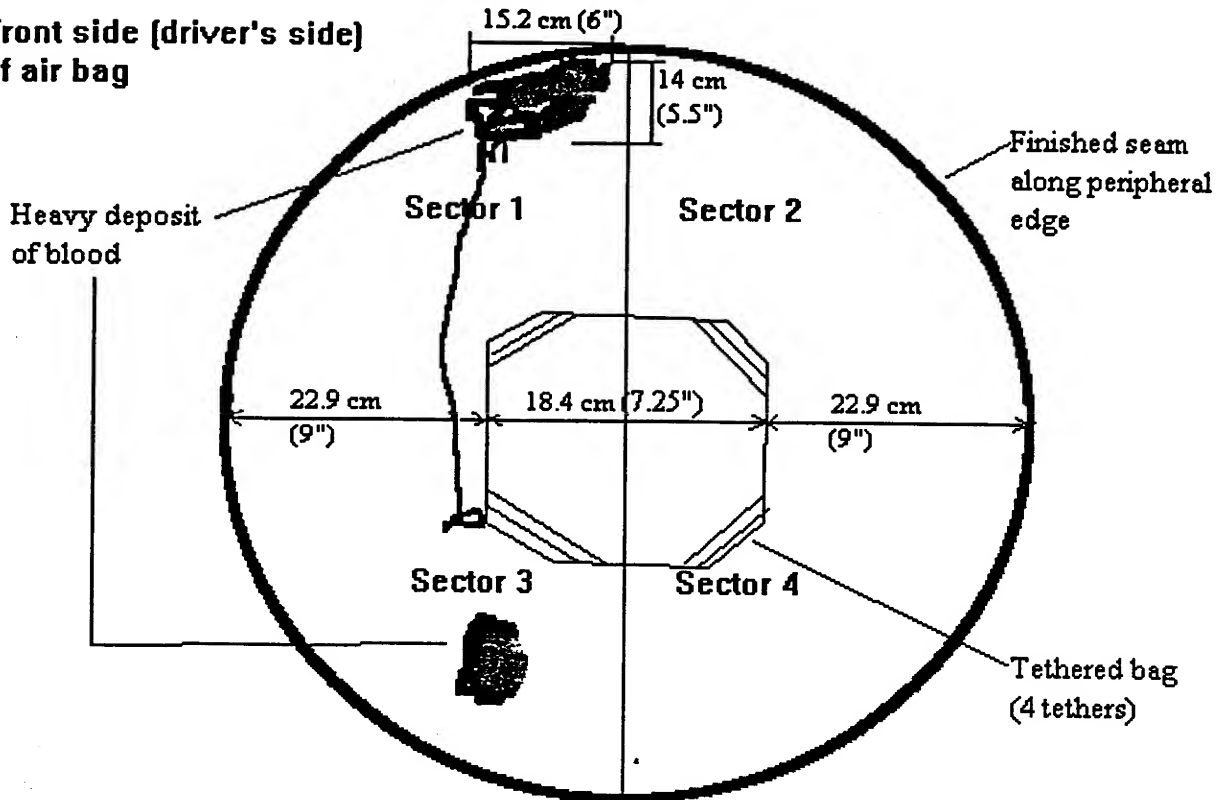
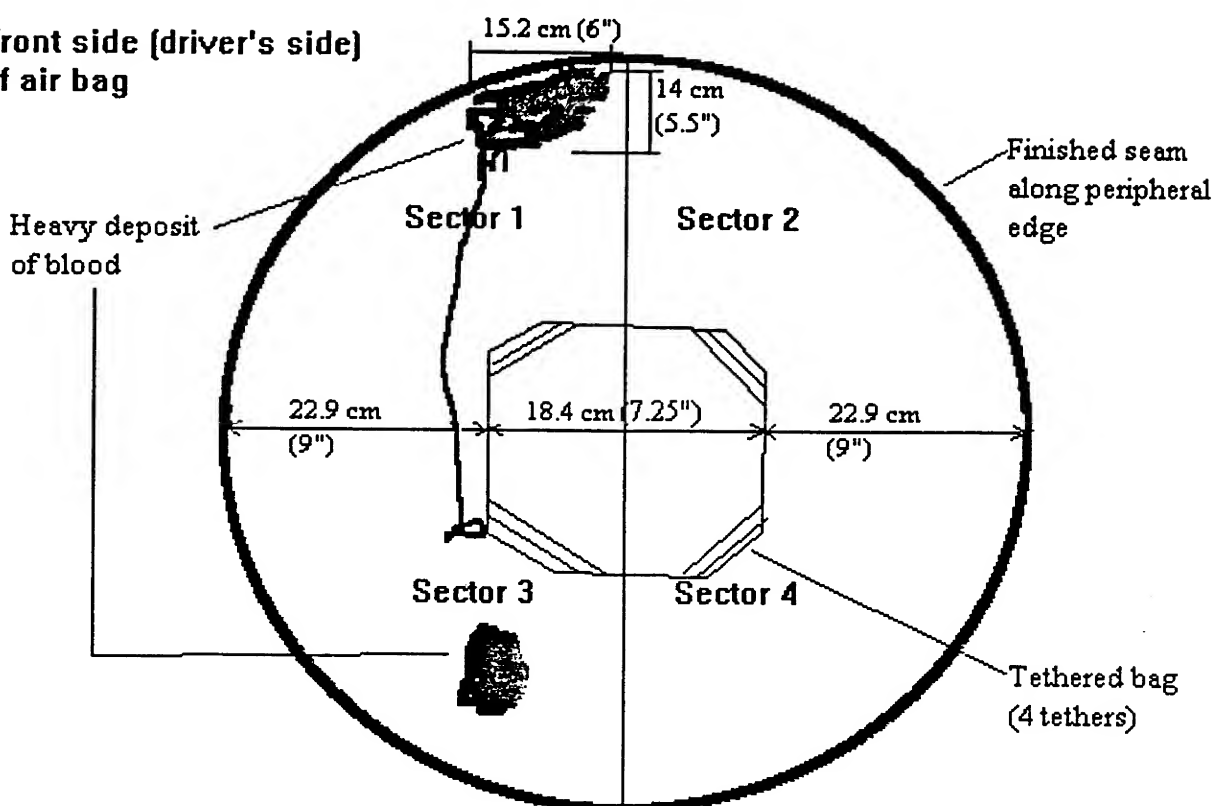
**Front side (driver's side)  
of air bag**

A red lipstick transfer was noted on the instrument panel side of the air bag along the top peripheral seam line left of the center line. Blood deposits from the driver were noted in the upper left and lower left quadrants (Sectors 1 and 3).

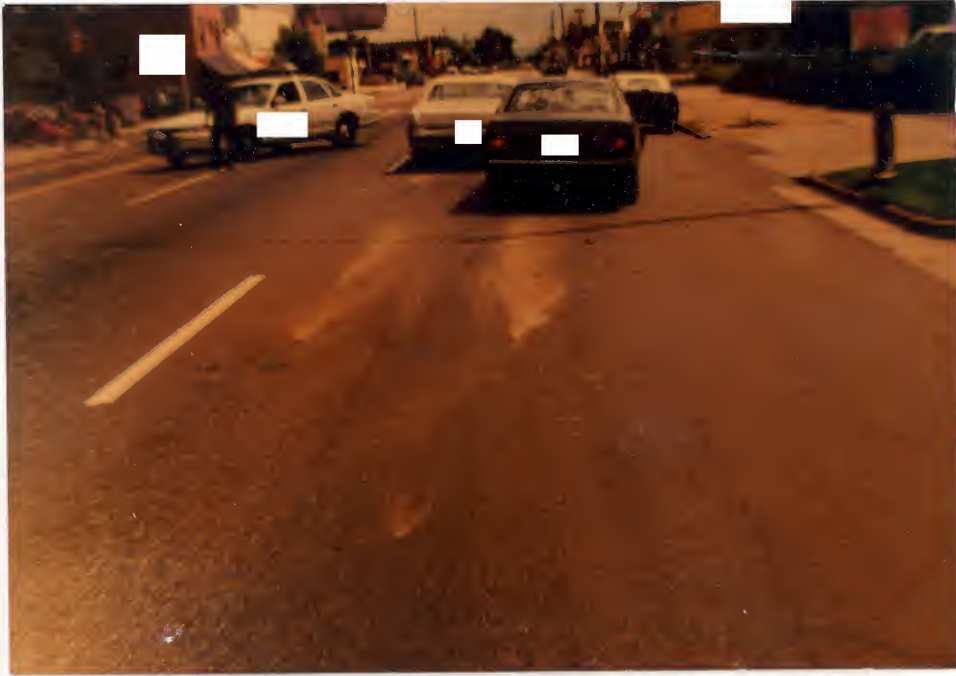
5. On-scene police photograph showing dirt debris from the undercarriage of Vehicle #2 at POI and post impact trajectory

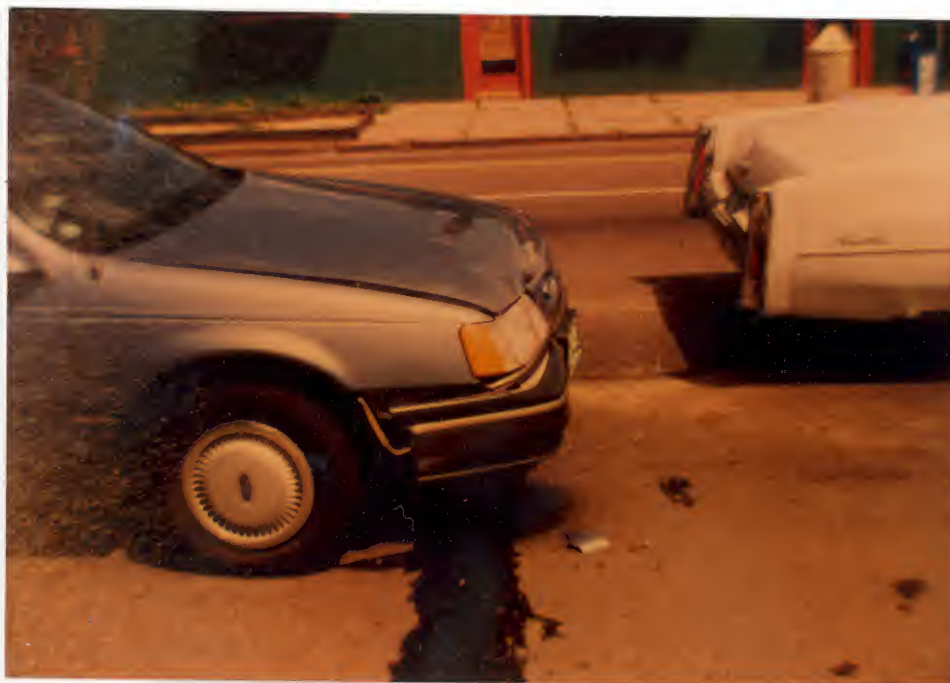
10. Lateral (easterly) view of both vehicles at FRP, highlighting the radiator spill and right front tire steer angle of Vehicle #1

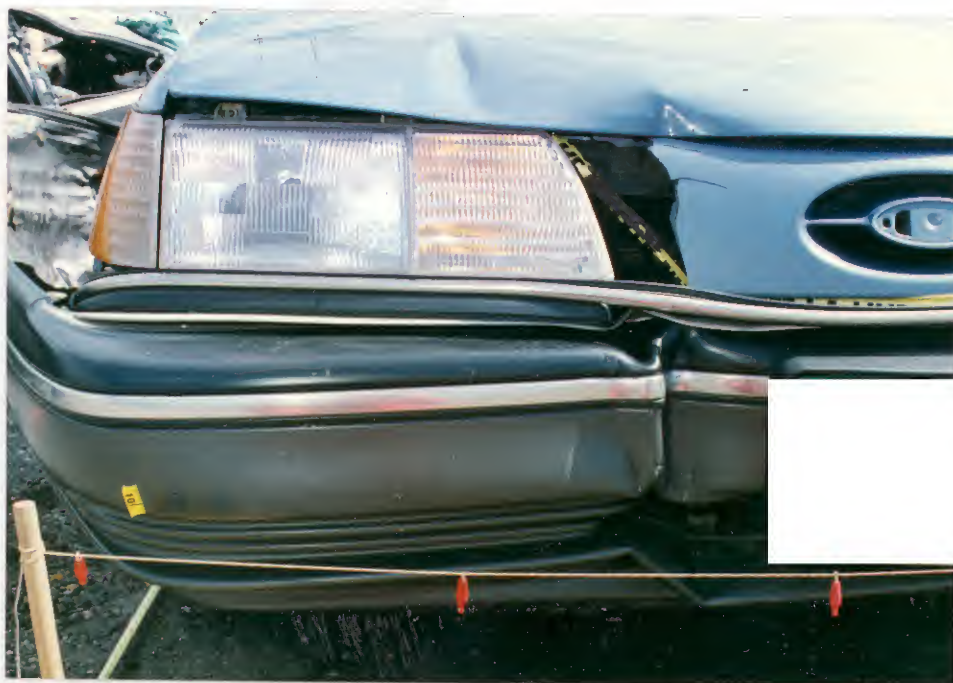
14. Close-up view of the front right section of Vehicle #1, highlighting the damage pattern on the bumper and grille panel consistent with the vertical design of Vehicle #2's right rear taillight

14.	Close-up view of the front right section of Vehicle #1, highlighting the damage pattern on the bumper and grille panel consistent with the vertical design of Vehicle #2's right rear taillight assembly

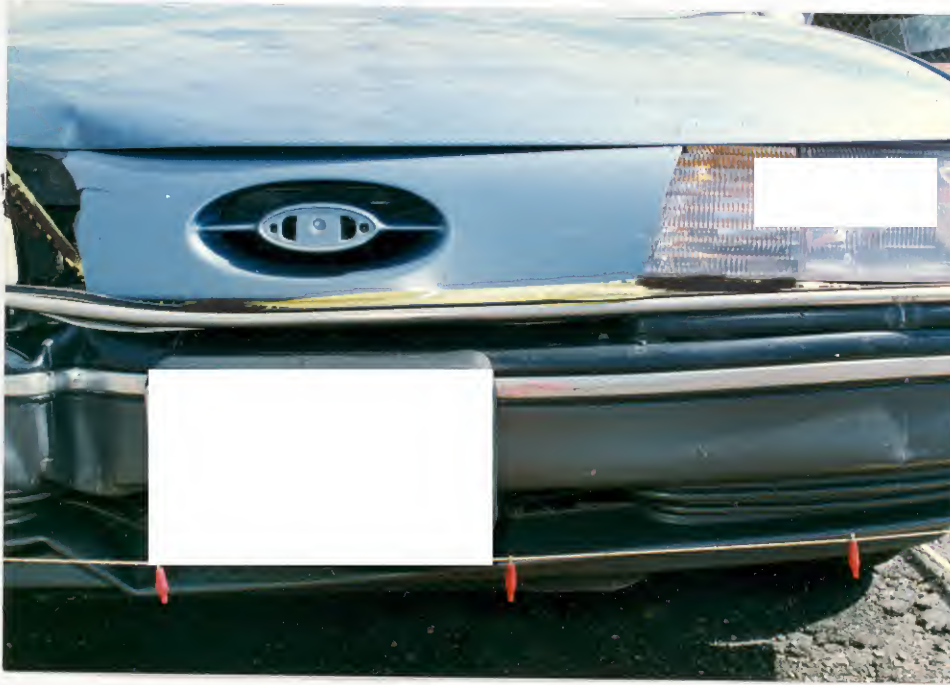
15. Close-up view of the front center section of Vehicle #1, highlighting damage along a mid line on the license plate which aligned with contact on Vehicle #2's rear bumper rub strip

15.	Close-up view of the front center section of Vehicle #1, highlighting damage along a mid line on the license plate consistent with contact on Vehicle #2's rear bumper rub strip

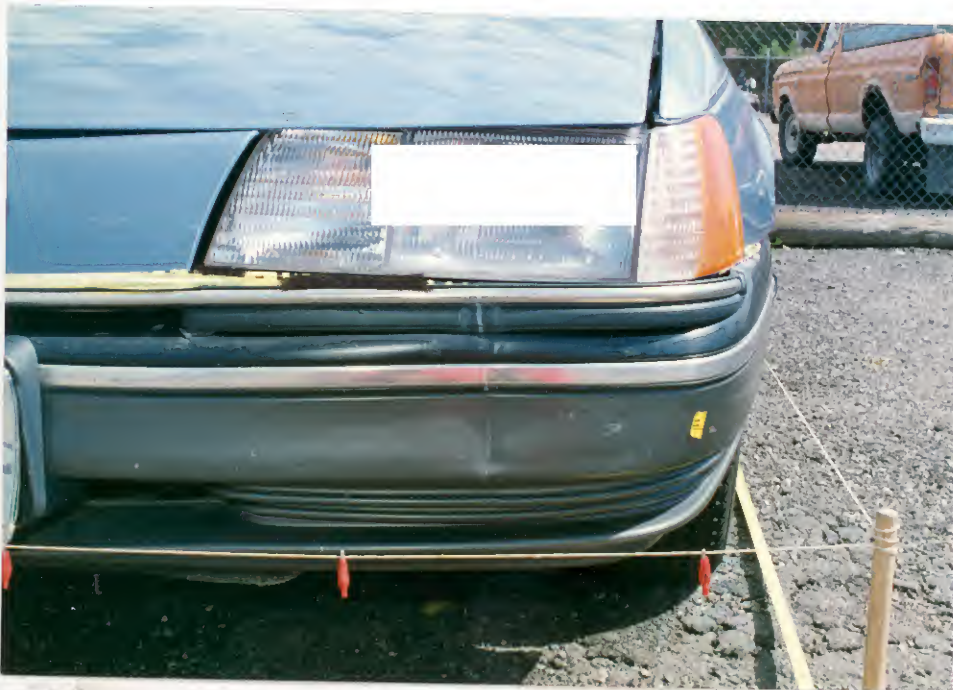
16. Close-up view of the front left section of Vehicle #1, highlighting contact damage on the bumper surface consistent in shape with the vertical right rear taillight assembly of Vehicle #2

16.	Close-up view of the front left section of Vehicle #1, highlighting contact damage on the bumper surface consistent in shape with the vertical right rear taillight assembly of Vehicle #2

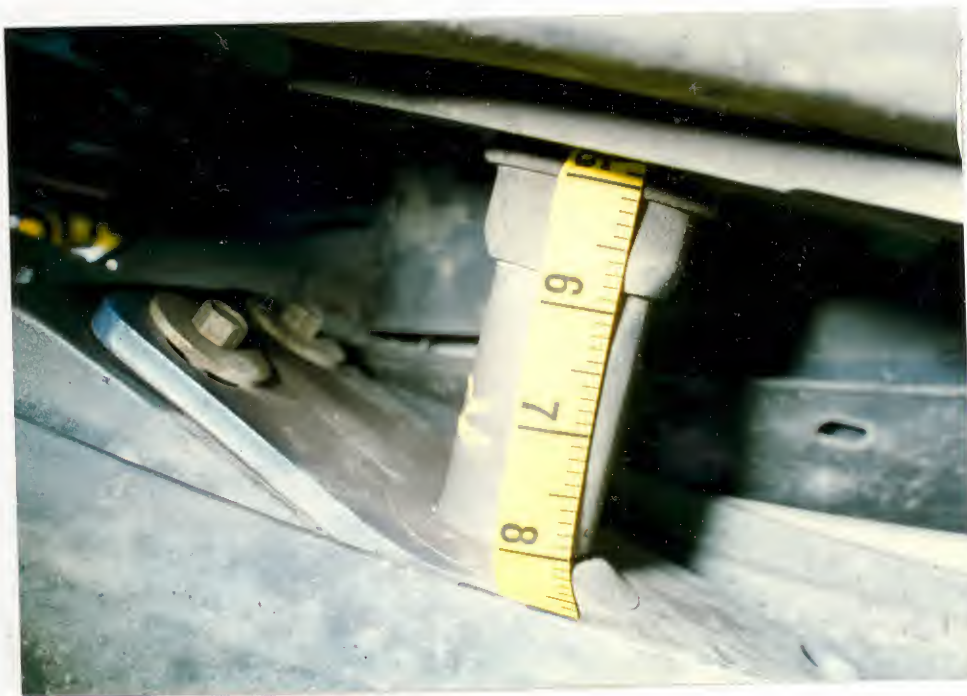
17. Right front bumper energy absorption device (EAD) of Vehicle #1 showing 0.3 cm (0.1") of compression with full restitution

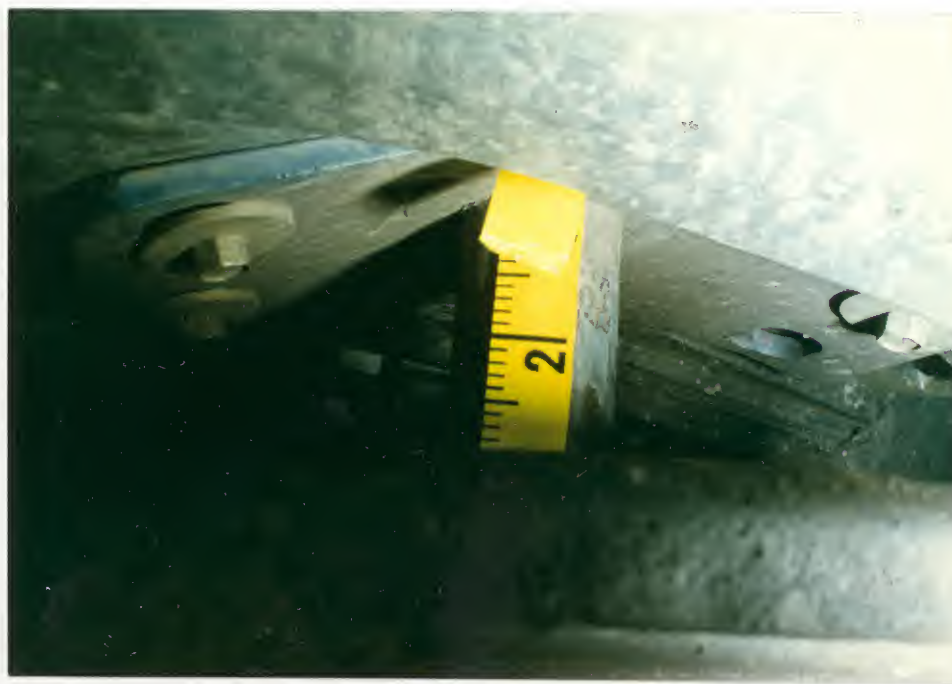
18. Left front bumper EAD showing 4.8 cm (1.9") of compression with full restitution

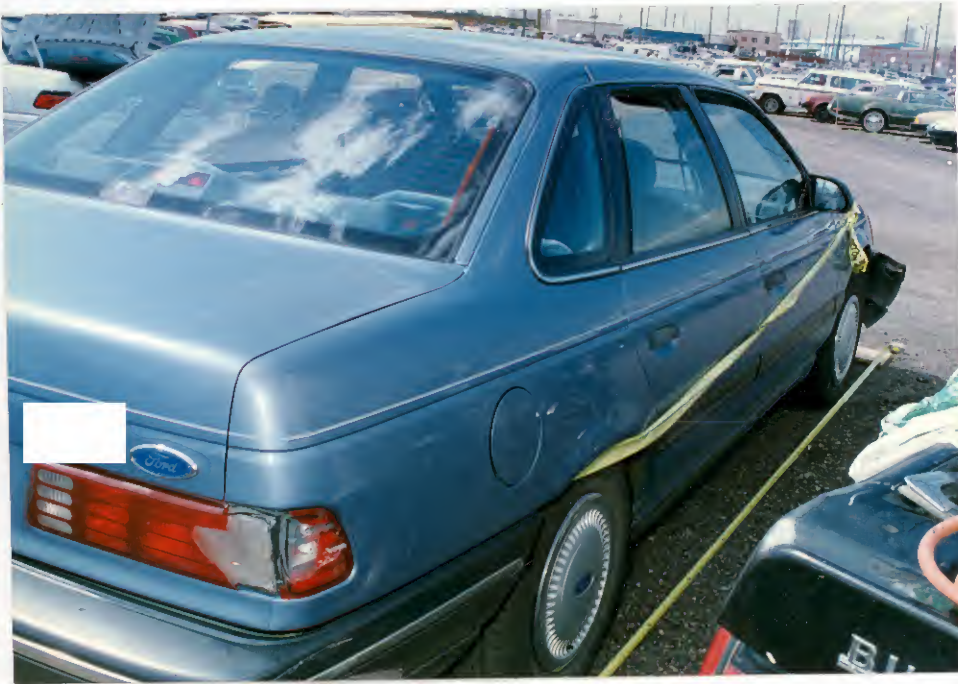
25. Right rear corner view showing broken taillight lens assembly (damage not related to crash)

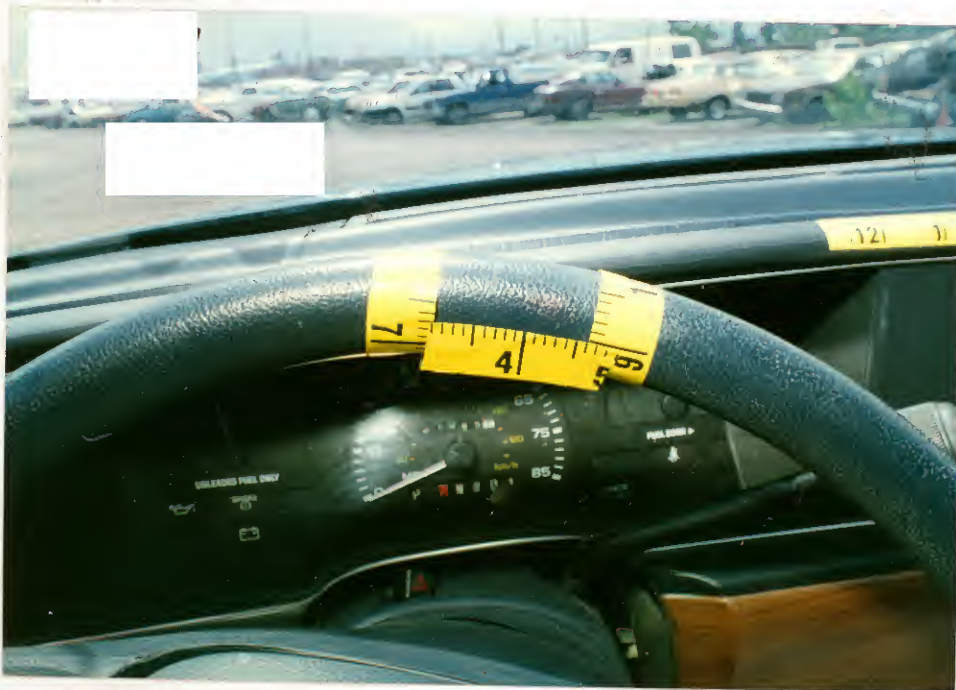
40. Close-up view of a red transfer mark on the upper steering wheel rim

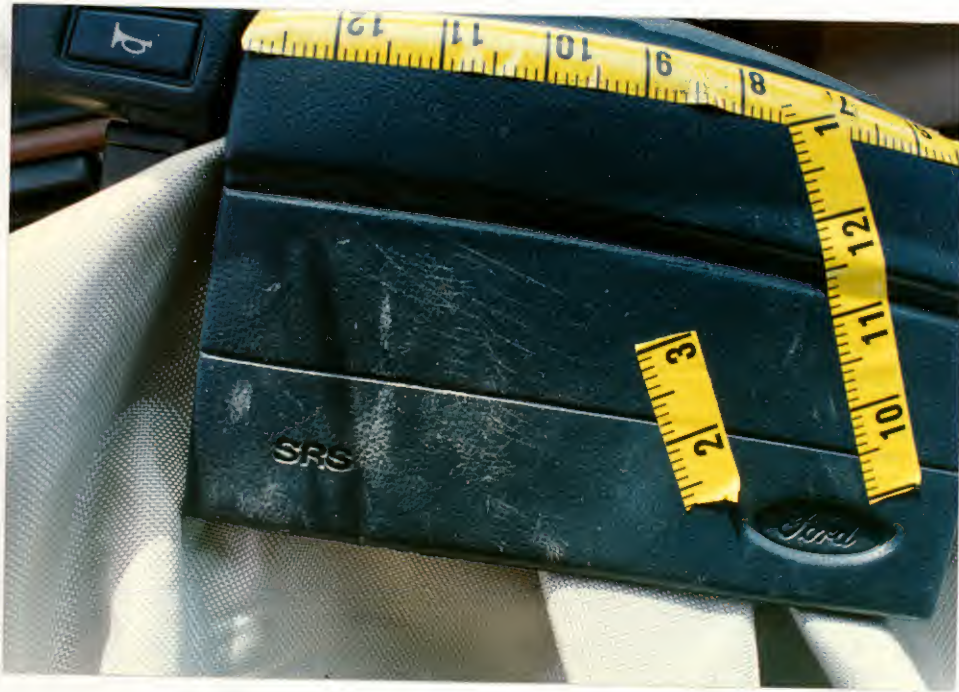
41. Close-up view of the upper flap of the air bag module cover, highlighting abrasions and skin transfers on the flap surface

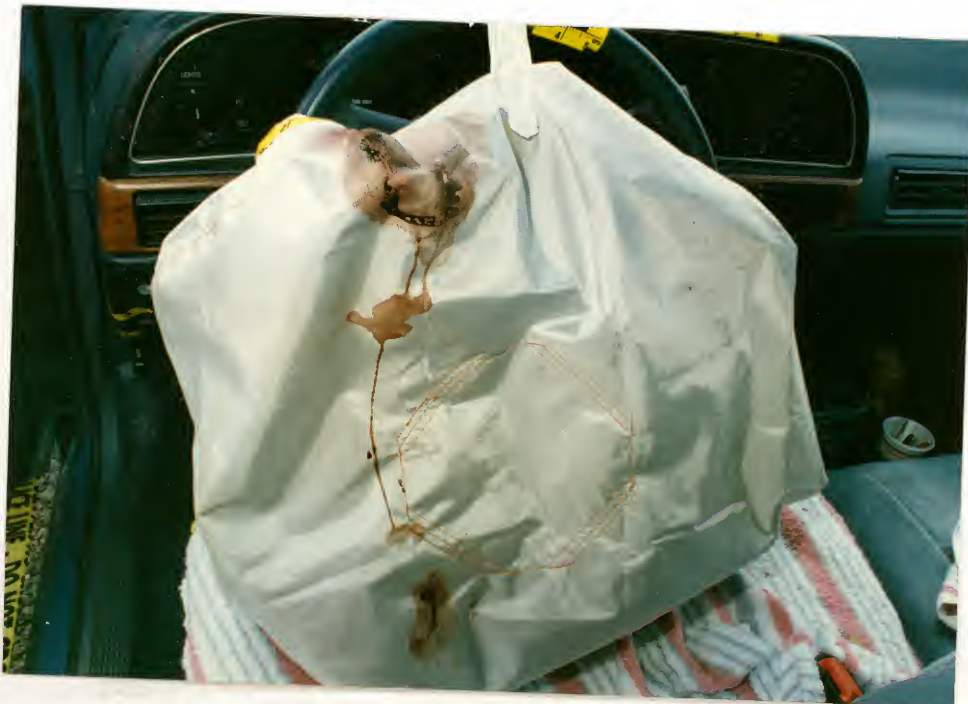
42. Overall view of the air bag showing blood stains

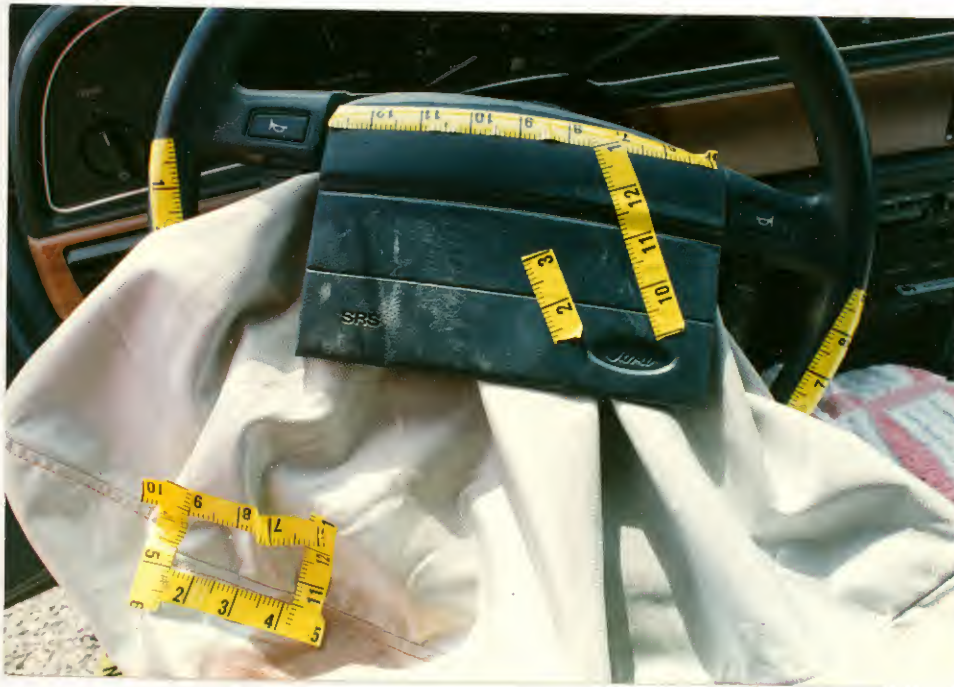
45. View of the air bag and upper flap of the air bag module cover with a red transfer (lipstick) mark on the air bag located on the instrument panel side of the peripheral seam line

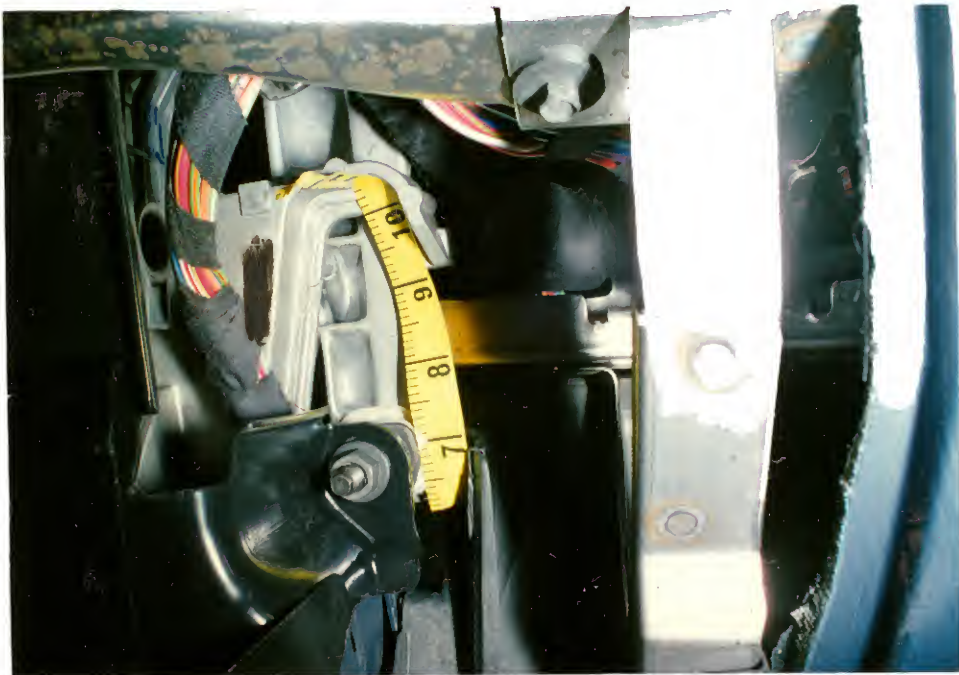
**Interior:** Interior damage was associated with contacts by the driver during the crash event. The steering column was displaced forward with movement of 7.0 cm (2.75") at the left shear capsule and 6.4 cm (2.5") at the right shear capsule. This displacement was the result of direct contact by the driver's thoracic area on the air bag module cover during the air bag deployment sequence. The upper half of the steering wheel rim was displaced forward 0.6 cm (0.25") by the air bag.

52. View showing the displacement of the left shear capsule
